BORON/ALUMINUM LANDING GEAR FOR NAVY AIRCRAFT

FINAL REPORT

GENERAL DYNAMICS
Convair Division

11
Sept 1978

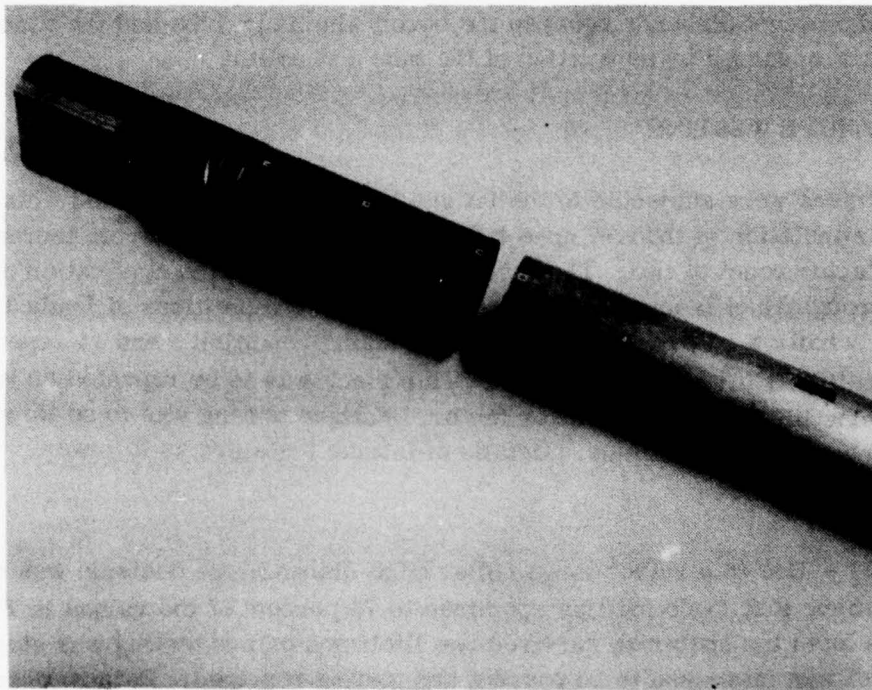
Figure 4-9. Failed Specimen 001

Specimen 001 - This specimen was first loaded in compression to 141,000 pounds (100% Design Ultimate Load) and then in tension to failure. Failure occurred at 220,000 pounds (93% Design Ultimate Load) when the composite tube fractured adjacent to the edge of one titanium collar, as shown in Figure 4-9. Visual inspection of the failure revealed collar damage adjacent to the failure surface in the form of an edge joggle. This condition, which is discussed in detail in paragraph 3.7.2, results in broken fibers and a notch-like stress concentration in an already high stress area. It is believed failure was primarily due to these broken surface plies.

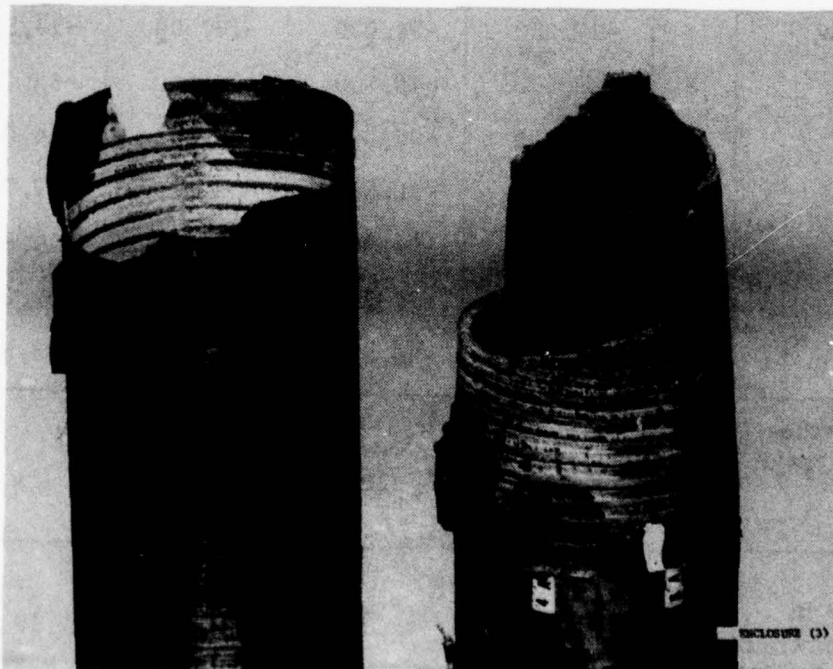
Figure 4-11. Specimen 003 Showing Failure of Joint Area

Specimen 003 - Due to a rather large collar edge disbond, the decision was made to reduce all fatigue test loads for this specimen to 75 percent of the values in Table 4-3. At this level the specimen survived two lifetimes before testing was stopped. The load level was increased to 80 percent and testing resumed. Failure occurred in the joint area after 0.5 lifetime. The original collar edge disbond propagated longitudinally into the joint until the total net section area was unable to sustain the catapult tension load. Propagation of the disbond was indicated by strain readings taken long before failure. The failed specimen is shown in Figures 4-10 and 4-11.

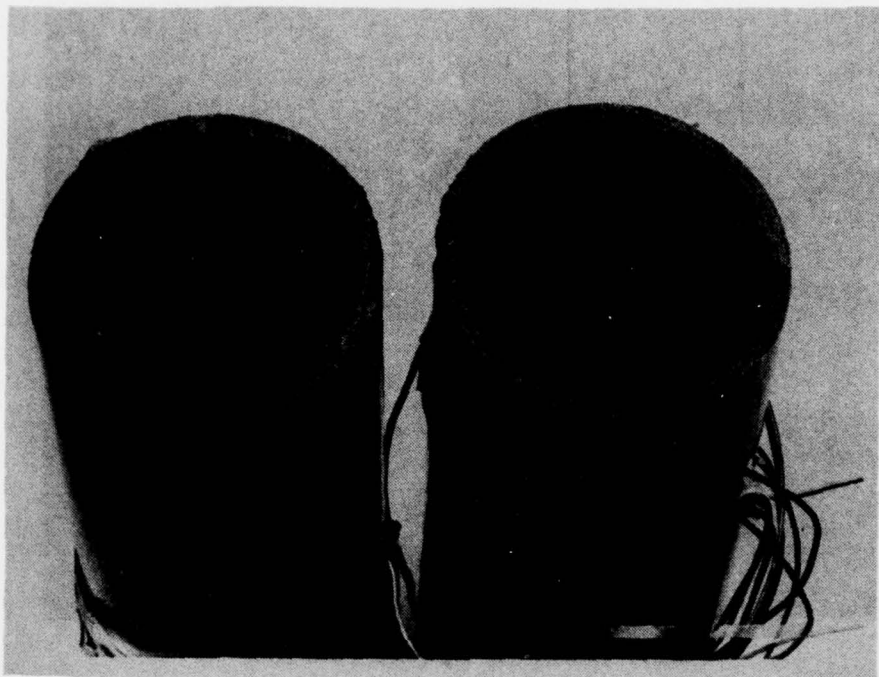
Figure 4-13. Failed Specimen 009 - Failure occurred through a 0.10 inch deep notch in the boron/aluminum tube wall.
